CASE STUDY

Damaged Casing Repair at Shallow Depth Tag Oil, New Zealand

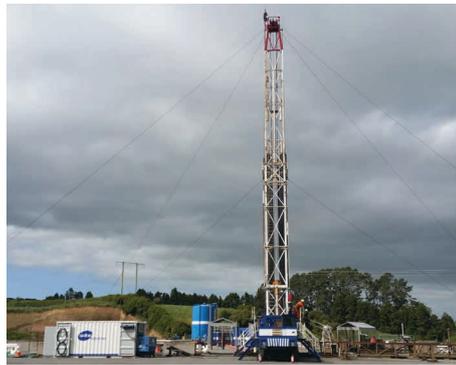
In a 9 year-old well, a communication between the 5^{1/2}in production casing and the 9^{5/8}in annulus had to be located then shut off.

The objective was to cover and seal off the hole using a Saltel Expandable Casing Patch, allowing the completion to be run through the patch.

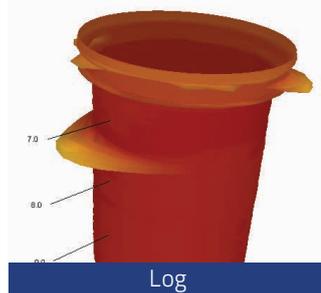
The depth of the leak was not known before the job; a 5.5in Reinforced SES Patch was selected in case the damaged zone had been located deep in the well, which would have require a high collapse pressure.

A multi finger caliper log allowed to locate the hole in the production casing 25.7m below the Tubing Hanger.

The patch and setting BHA were conveyed with 2^{7/8}in tubing on a service rig and positioned by tubing tally.
