**Gravel Pack Isolation in Drinkable Water Well**  
Nominal: 13.41in / 340.5mm  
Drift: 13.25in / 336.5mm

# Water-well turbidity reduction in a slotted screen France

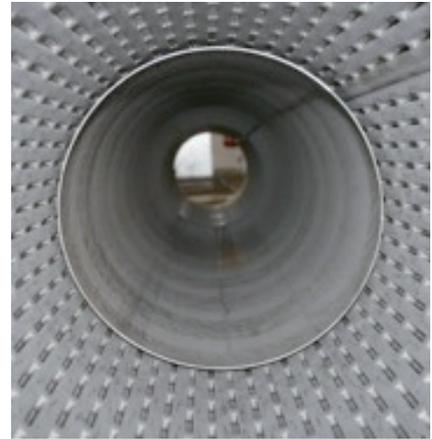
### Test-Patch Expanded in a strainer

Saltel Industries performed shop tests on an identical slotted screen and determined that the patch could be anchored with no damage to the slotted-casing, if less than 650psi was transmitted to the casing.

- an accurate positioning of the expansion packer when expanding (to avoid the contact of the inflated packer with the screen)
- the pressure monitoring (to avoid applying too much pressure to the screen through the patch)

The patch has been expanded in 17 steps.

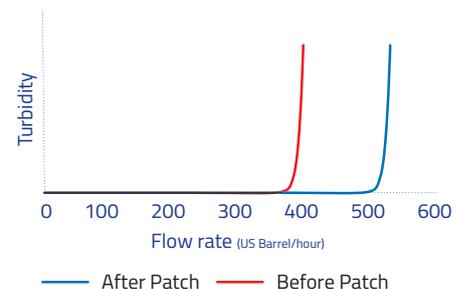
### Turbidity vs flow rate

The client was satisfied by the solution since the patch increased the turbidity threshold point, enabling production gain of 125 US barrels per hour with no turbidity. Also, for a given pumping rate, no fluid level drop was observed compared to previously.
