Saltel Steel ECP demonstrates unusual resilience despite severe RIH conditions

Run through tight spot, stuck and worked for several hours before pull out of hole, checked intact on the surface then successfully re-run and installed

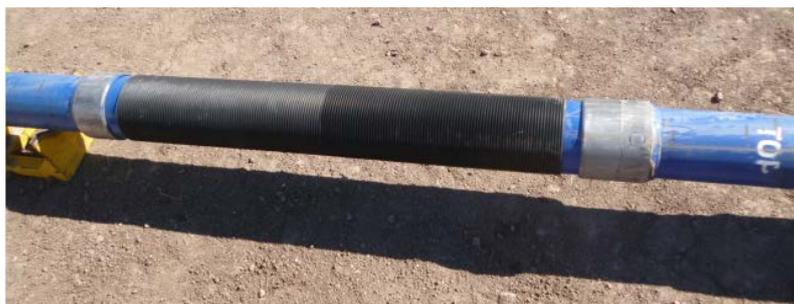
Photograph of Steel External Casing Packer (Saltel Steel ECP) after pull out of hole preceding the 2nd run: No damage indicating the product has been run through tight spot

When pulling the casing back to surface, the SES ECP showed no signs of deformation and looked "good as new" as per client words.
